On-line monitoring of cracking in concrete structure using embedded piezoelectric transducers

C. Dumoulin¹, G. Karaiskos¹, J-Y. Sener² and A. Deraemaeker¹

¹ Université Libre de Bruxelles (ULB), BATir Department, 50 av F D Roosevelt, CP 194/02, B-1050 Brussels, Belgium.

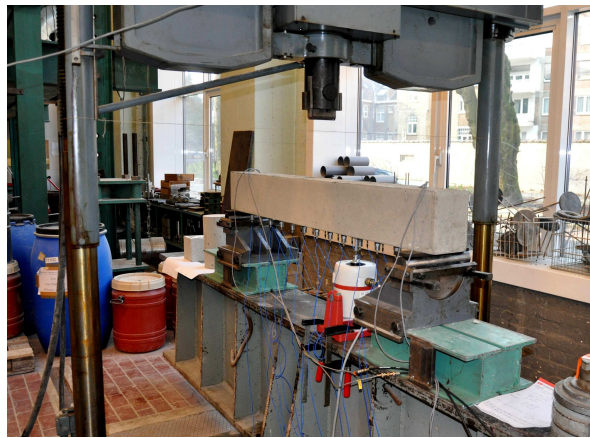
Figure 8. Bending testing machine

The loading machine used for the experiment is a 200kN hydraulic jack bending testing machine (Figure 8). The test was performed in two different phases. In the first phase, the beam is totally unloaded slightly after appearance of the first cracks. Figure 9a

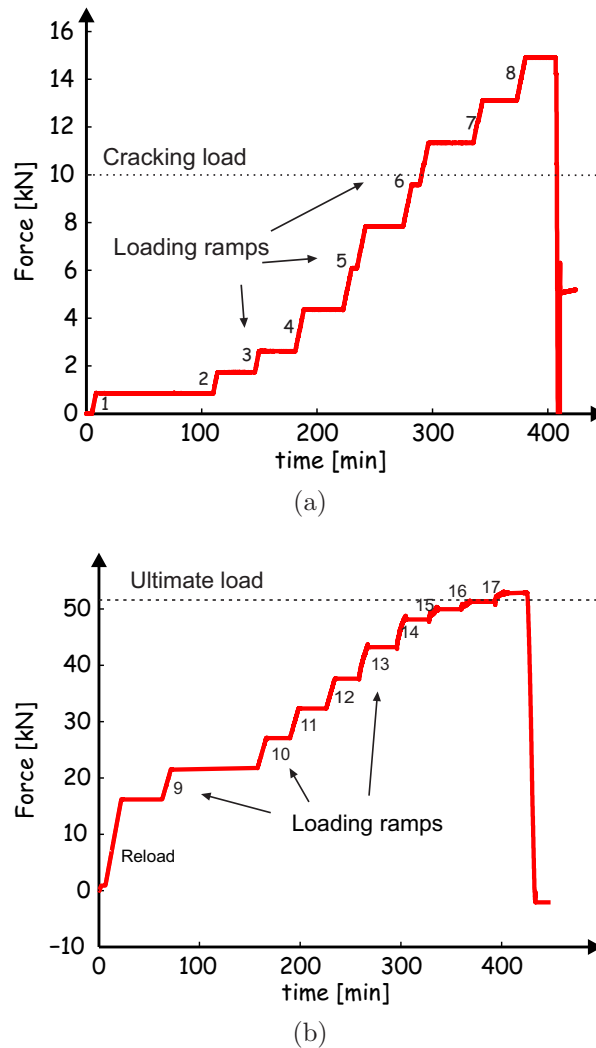
Figure 9. Loading procedure for the RC beam. a) Phase 1. b) Phase 2

summarizes the loading procedure of the first phase. The loading procedure for the second phase is shown on Figure 9b; the beam is loaded close to the maximum acceptable load. During the second phase, in addition to the force and displacement sensors of the testing machine, a LVDT extensometer (Linear Variable Differential Transformer) is used to measure the deflection at center of the beam and six other LVDT extensometers (3 on each side) are used to measure cracks width. Cracks width has therefore only been measured on the second day. Extensometers are then correctly placed to measure the main cracks width which appeared after the first phase.

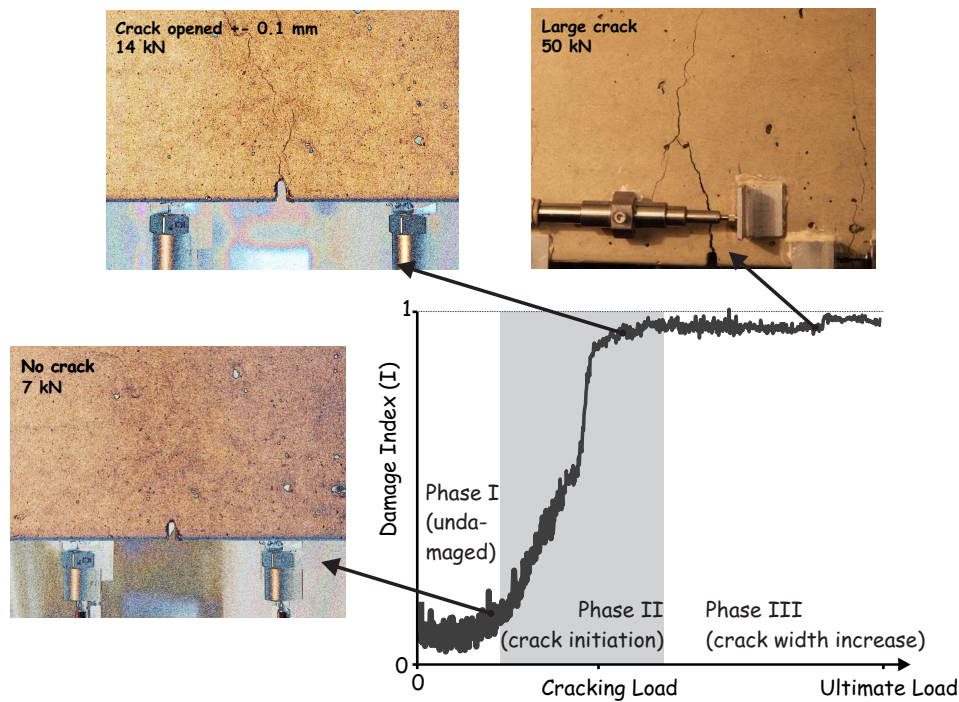
Figure 11. Damage index for the RC beam, comparison with the visual observations

Figure 11 shows the evolution of the damage index for the pair of SMAGs that are located near the bottom of the beam (A18g-A17g on Figure 6). Unfortunately, the

The evolution of the damage index shows a good correlation with the observations during the experiment. This damage indicator increases between 5 and 15kN which are the values of the initiation of the observed cracks. This index saturates after the appearance of cracks and therefore, does not evolve anymore when crack is growing. It saturates largely before the service limit. This index is an excellent indicator for detecting crack appearance but does not give any information about the the evolution or the size of the damage.

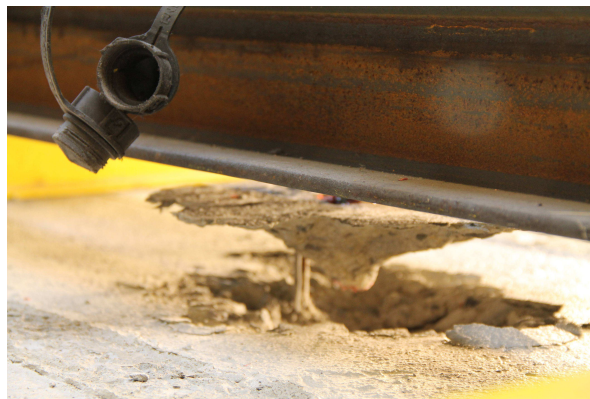
Figure 12. Pull-Out test: concrete cone at ultimate load

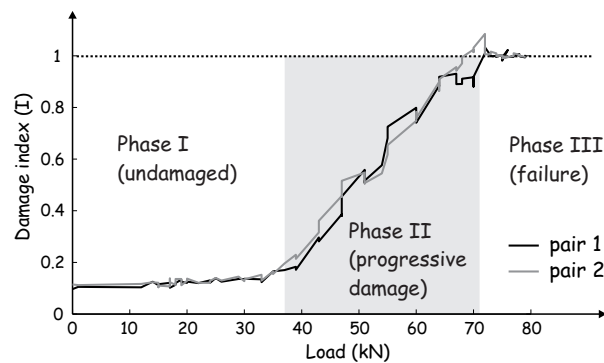
Figure 14. Damage index block 1 as a function of load

Figure 14 shows the evolution of the damage index for the test performed on block 1. The figure shows that the damage index evolves in the same manner for the two pairs which is representative of the symmetric failure of the concrete in the form of a cone. The graph clearly shows three phases: in the first phase, the damage indicator is very low but non-zero due to a certain level of noise in the signals. The second phase corresponds to the initiation and evolution of damage in the concrete until complete failure (phase III) where the damage indicator is unitary due to the fact that the wave cannot reach the receivers anymore as the concrete cone is fully detached from the block.

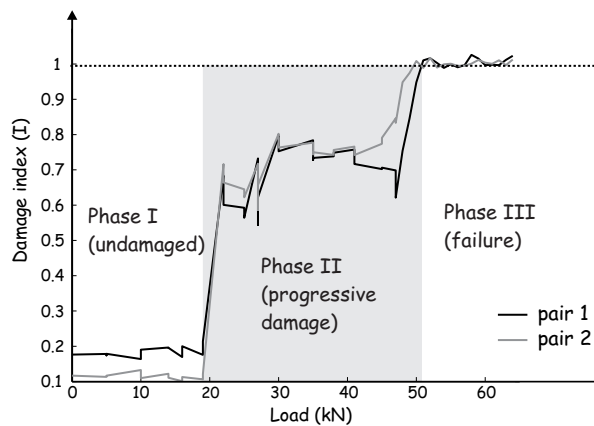
Figure 16. Damage index block 3 as a function of load

The evolution of the damage index for blocks 2 and 3 is represented on Figures 15 and 16. For block 2, the damage starts earlier, and the failure is less symmetric than for block 1 as evidenced by the difference between the damage indicator for the two SMAGs pairs mainly in phase II. For block 3, the damage phase shows two major jumps representative of two sudden cracking events.
